## **NATIONAL TRANSPORTATION SAFETY BOARD**

# **AIRFRAME / ENGINE EXAMINATION, AND MAINTENANCE RECORDS SUMMARY REPORT**

**WPR15FA121**

Location:	Santa Monica, California
Date:	March 5, 2015
Aircraft:	Ryan Aeronautical ST-3KR, N53178
NTSB Investigator-in-Charge:	Albert P. Nixon

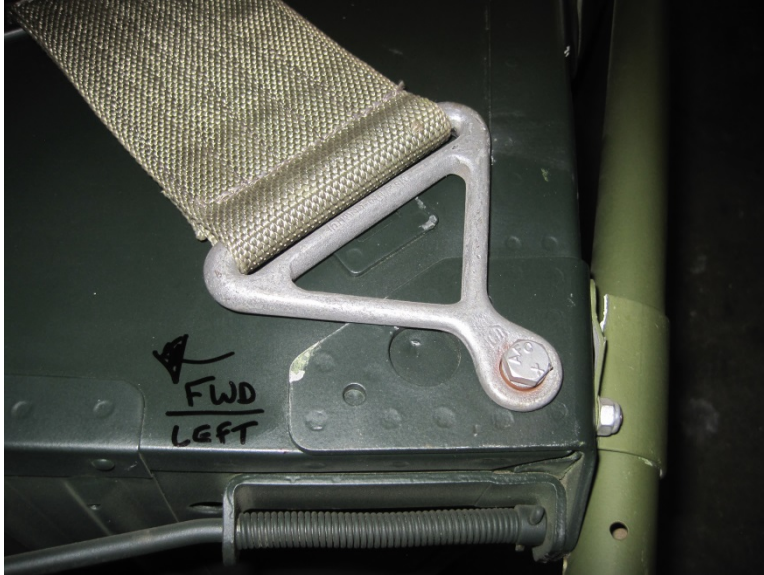
Photo 1: Aft seat left side lap belt attach point.

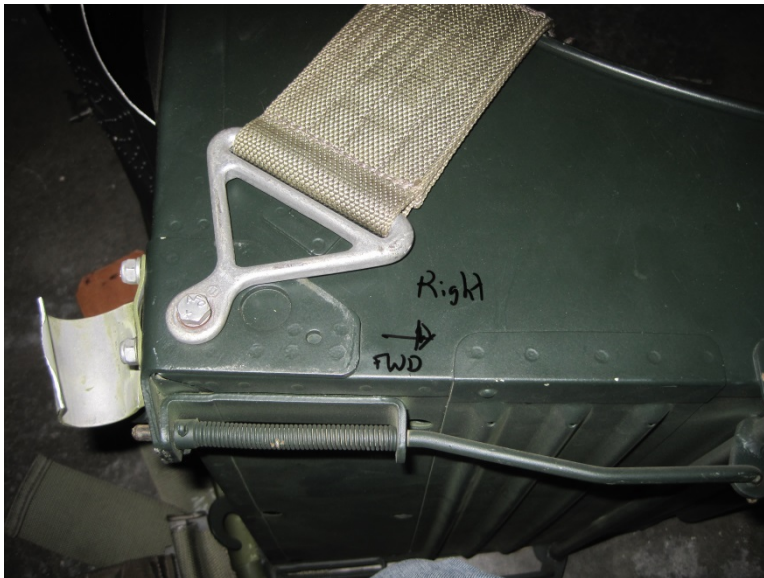
Photo 2: Aft seat right side lap belt attach point.

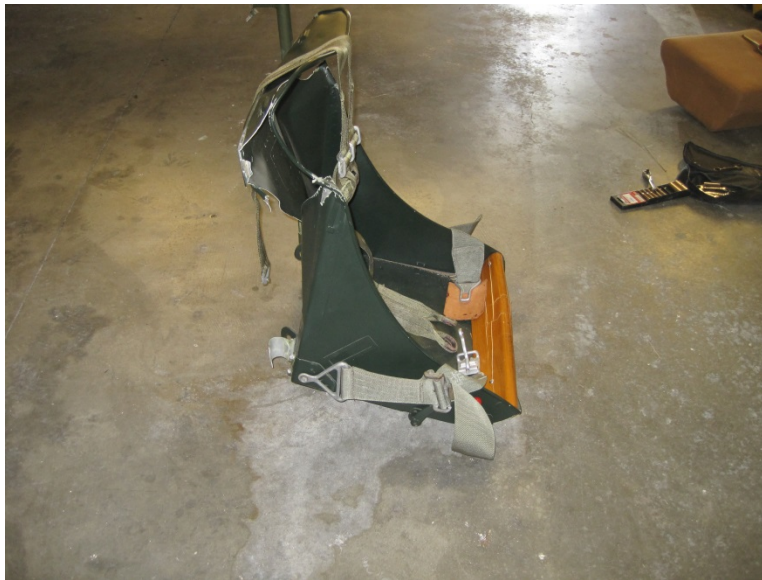
The aft seat remained attached to the airframe via its mounts. The lower right aft attach bracket was separated, and exhibited impact damage. The upper back portion of the seat was bent forward and downward. The seatback pan was wrinkled and distorted. The right side of the seatback was partially torn from the upper right corner extending downward at a 45-degree angle toward the middle of the seat back. The wooden seat structure on the front bottom side was splintered downward.

**Photo 3: Aft seat, side view.**

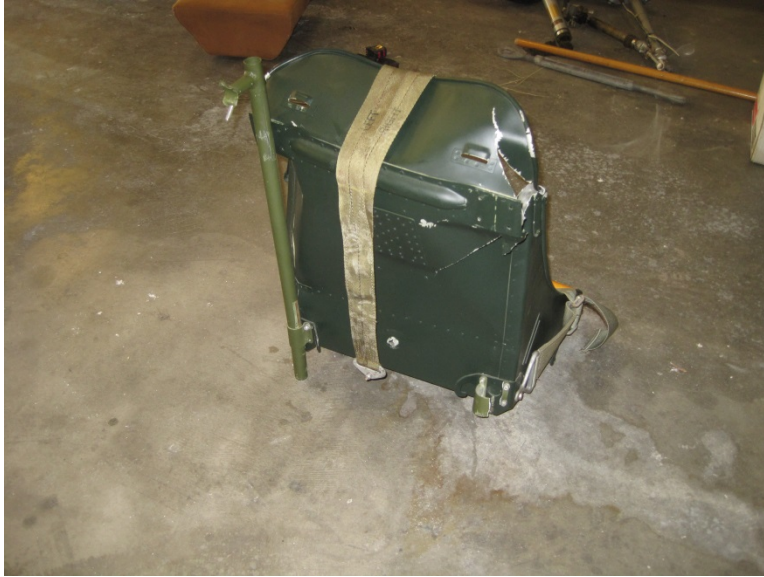
**Photo 4; Aft seat, rear view.**

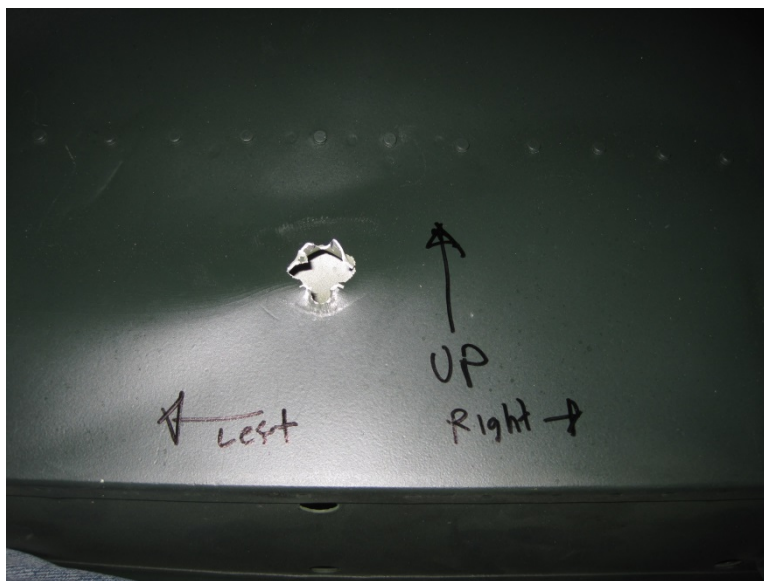
The left and right seat belt restraints remained attached to their respective mounts and seat structure. The shoulder restraints were separated, however, the attach bolt remained intact and secure to the shoulder restraint harness. The shoulder harness restraint appeared to have been attached using an AN3-3 bolt, two AN-960 washers, and an AN365 elastic stop nut. A hole, similar to the size of the shoulder harness attach bolt, was observed on the back of the seat, about 2 and 3/8ths inch above the seat bottom. The aluminum structure of the seat back was peeled away (outward and upward) from the shoulder restraint bolt hole, consistent with the attach bolt being pulled through the metal structure. There was no evidence of installed reinforcement surrounding the shoulder restraint bolt hole and peeled away seatback structure.

**Photo 5: Aft seat, shoulder harness attach point.**

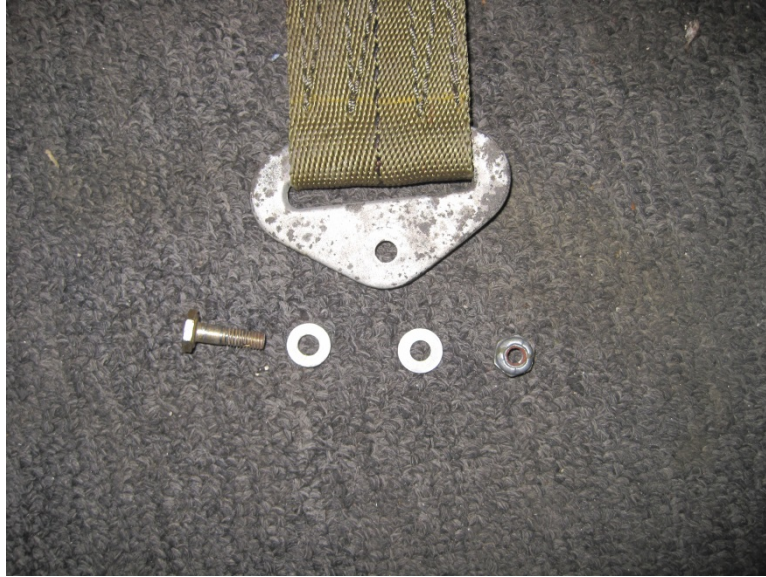
**Photo 6: Aft seat shoulder harness attach bracket and hardware.**

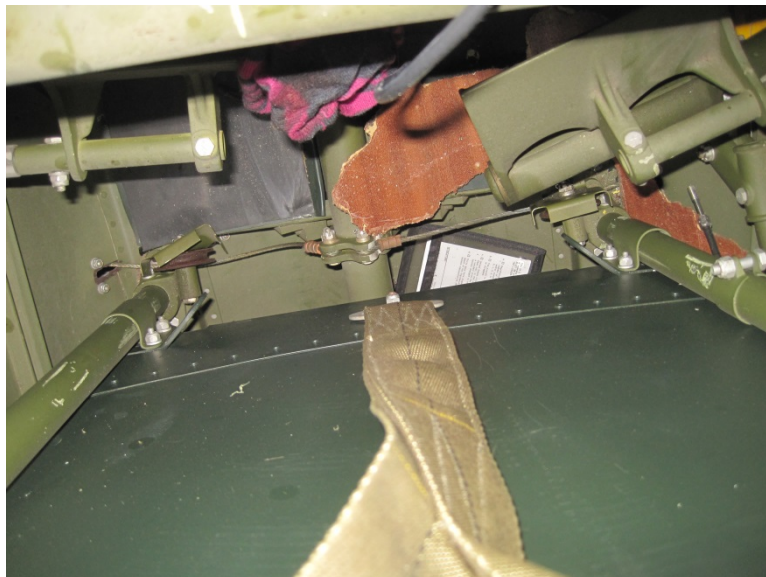
The front seat was intact, and not removed. However, the shoulder restraint appeared to be installed in a similar fashion to the aft seat.

**Photo 7: Front seat shoulder restraint attachment.**

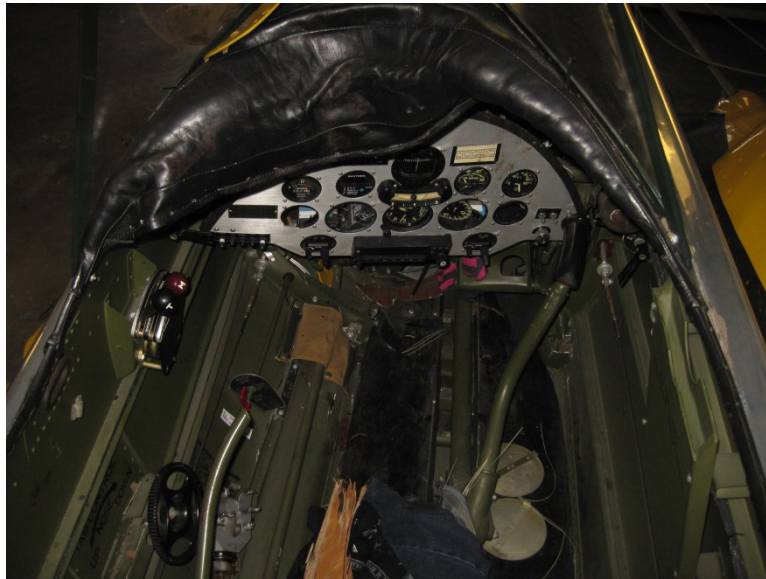
The upper portion of the aft cockpit structure, which was covered by leather material, was compressed forward, and displaced downward. The instrument panel structure was displaced forward.

**Photo 8: Aft seat dash and instrument panel.**

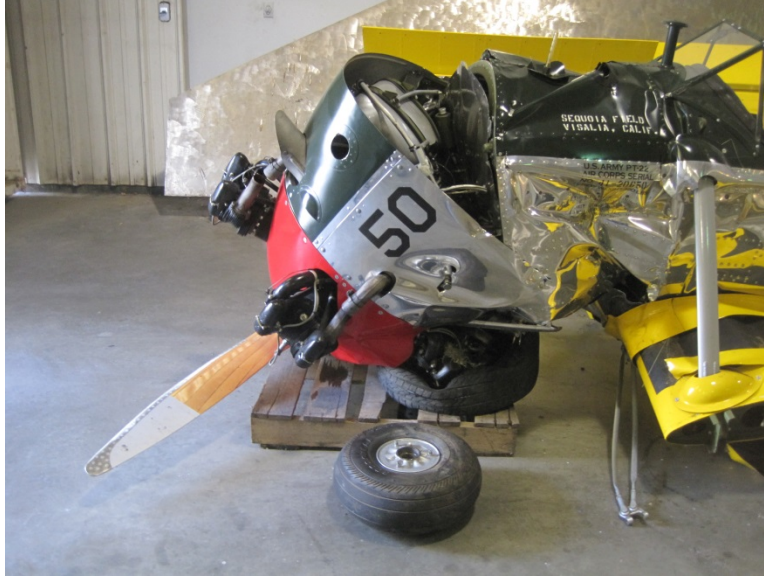
Examination of the recovered Kinner R-55 engine, serial number 07450, revealed that it remained attached to the airframe engine mount, and displaced downward at an approximate 45-degree angle. The starter was separated from the starter adapter, and the carburetor was displaced from its respective mounts. Impact damage was observed on the bottom side of the oil tank, and the outlet port was damaged and pulled away at the fitting, which resulted in a breach of the oil tank. When the engine was attached to an engine hoist, residual oil was observed draining from the oil tank outlet port. The oil shut off valve was found separated from the oil tank outlet fitting and the associated oil line tubing. The oil shut off valve was found in the open position, and the handle was bent, consistent with impact damage. When actuated by hand, the oil shut off valve actuated normally between the open and closed positions. Several fuel and oil lines were found impact damaged and separated. The oil drain valve was intact, and in the closed position.

**Photo 9: The engine as recovered.**

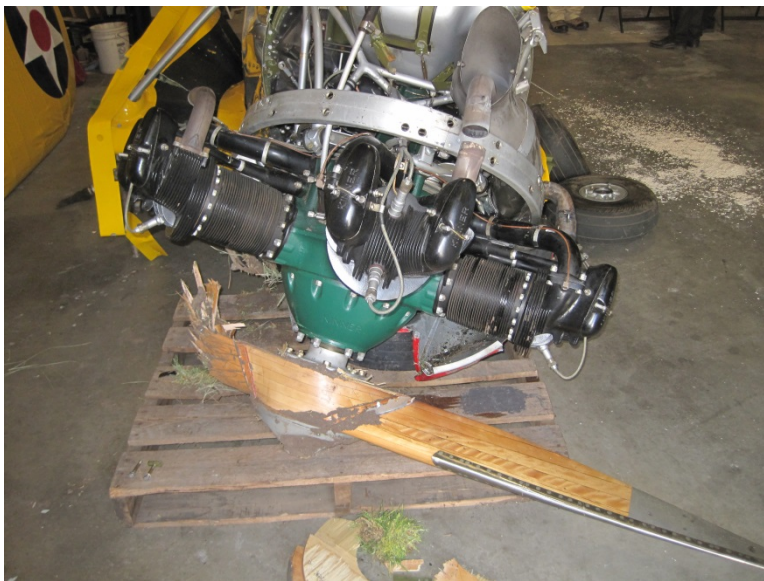
All five cylinders remained attached to the engine crankcase. Cylinder number one was intact and undamaged. The exhaust stack was separated from the exhaust shroud. Cylinder number two was intact and undamaged. The intake tube, intake and exhaust push rod tubes exhibited impact damage. The number three cylinder was intact and mostly undamaged. The intake rocker box cover was separated, and dirt/debris was found within the intake rocker box. The intake tube and exhaust were impact damaged. The intake and exhaust push rod tubes exhibited impact damage. Cylinder number four was intact and undamaged. The intake tube and exhaust were impact damaged. The exhaust pushrod tube was impact damaged. Cylinder number five was intact and undamaged. All cylinder rocker boxes exhibited internal grease around the intake and exhaust rocker arms. No evidence of any damaged springs was observed.

**Photo 10: The engine as recovered with cowling removed.**

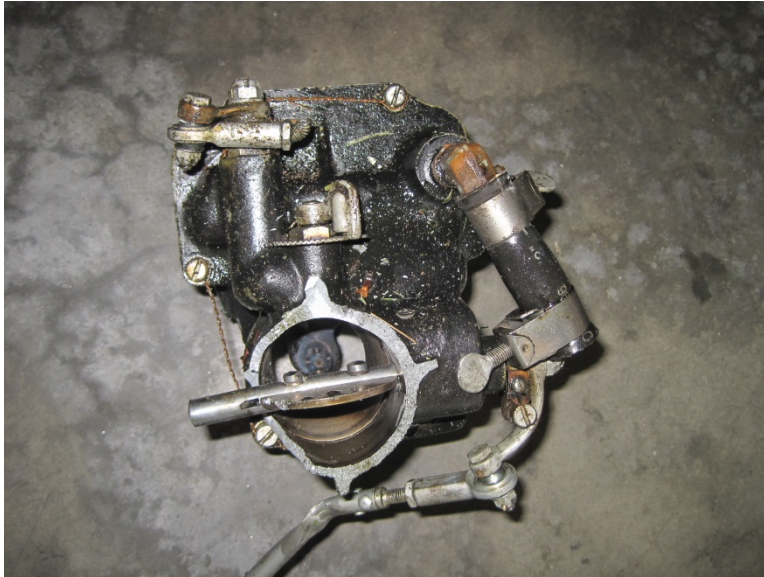
The Holley 419 carburetor was found separated from its mounts. The mounting flange and a portion of the carburetor casing around the throttle valve/plate were separated. The dataplate for the carburetor was separated, and not located. The idle mixture control arm was found near the full lean position. The observed position of the control arm was most likely due to impact forces and damage. The throttle plate was found in the full open position. The throttle and mixture control arms moved from stop to stop when actuated by hand. All safety wire was intact and secure. The carburetor was disassembled and examined. The fuel screen was intact and free of

**Photo 11: The carburetor as removed.**

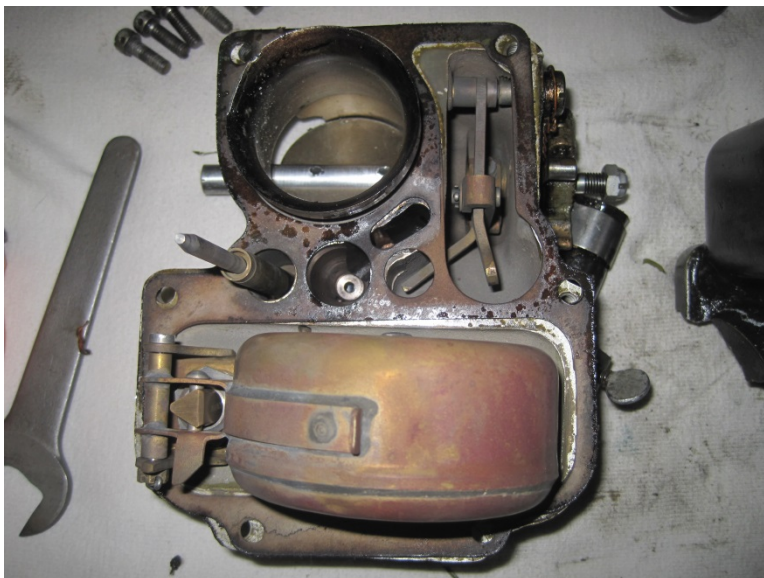
**Photo 12: Carburetor float and housing.**

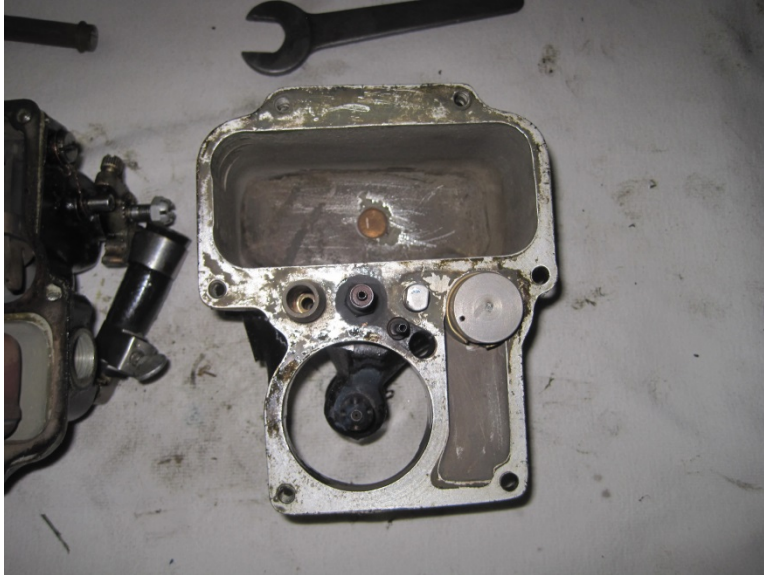
**Photo 13: Carburetor float bowl and housing.**

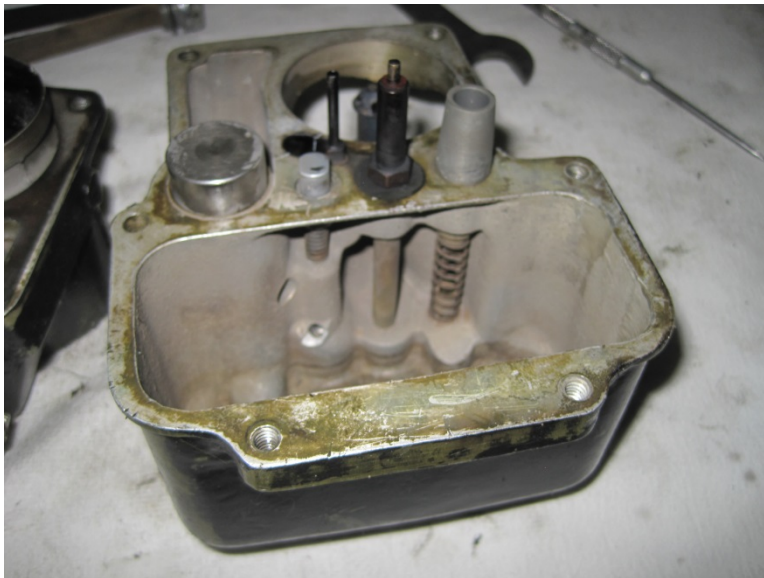
**Photo 14: Carburetor float bowl and housing.**

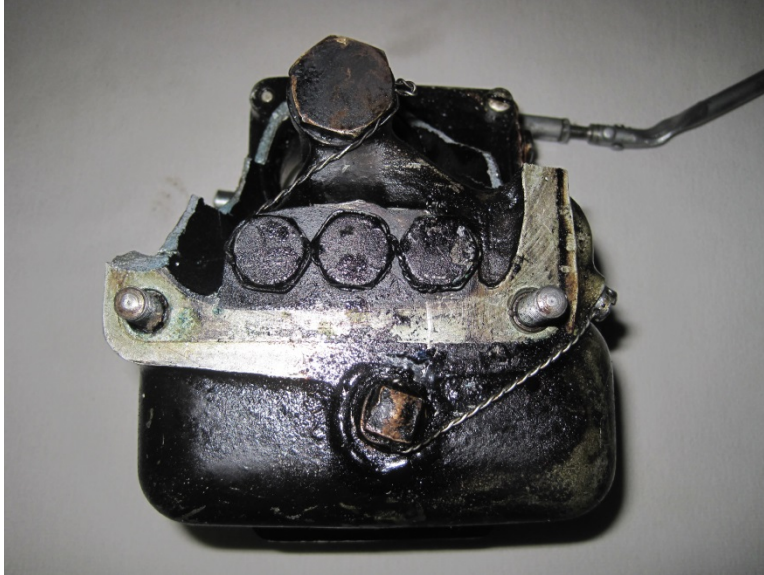
**Photo 15: Carburetor jet covers as found.**

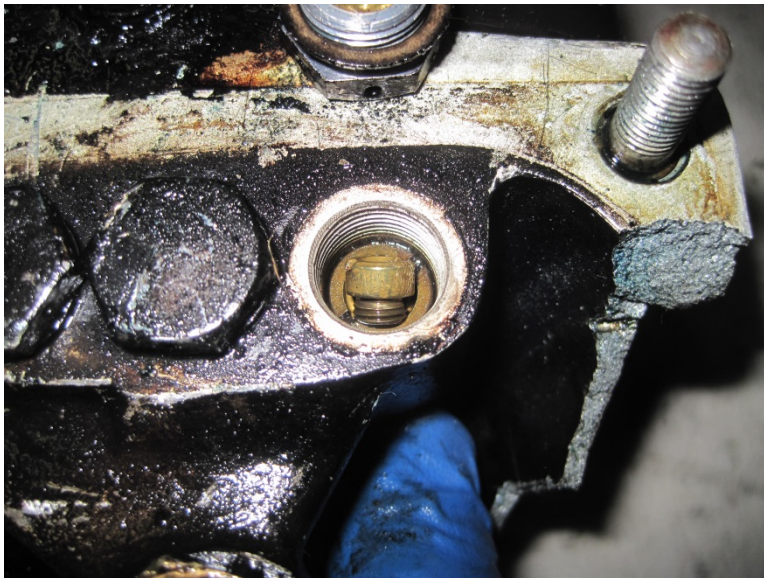
The main metering jet cover was removed, and the main metering jet was found unscrewed from its seat. The metering jet was observed rotated laterally about 90 degrees. The internal cap, main metering jet, and seat appeared to be bright in color and polished. Portions of the jet threads appeared to be rounded off. No gasket was observed within the main metering jet housing. In addition, no evidence of thread locking compound was observed on the threads of the fuel jet or the threads of the seat.

**Photo 16: Main metering jet and housing after cover was removed.**

The main metering jet orifice measured 0.104 inches in diameter, and the main metering jet holder orifice measured 0.128 inches in diameter.
